Minimum Material Condition (MMC)
2016-18 CHEVY SILVERADO 1500 HID LED LH UPR INBOARD HEADLIGHT TAB
P/N 25-10041

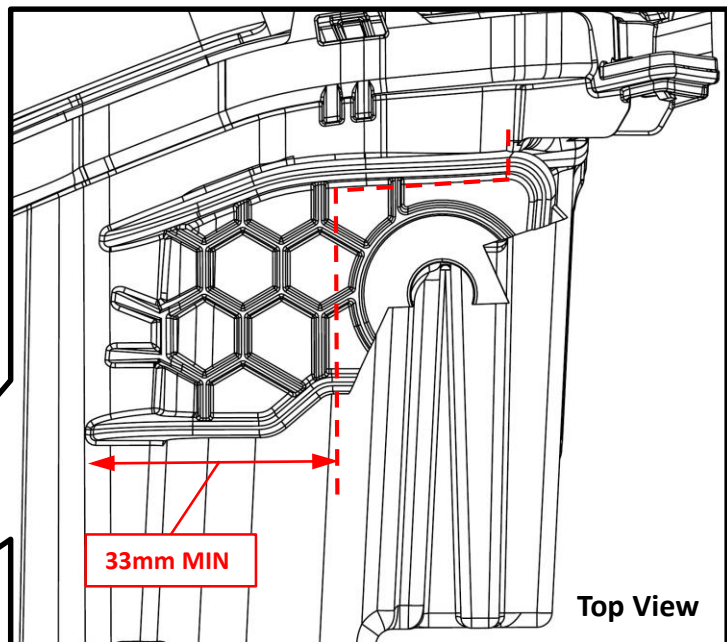
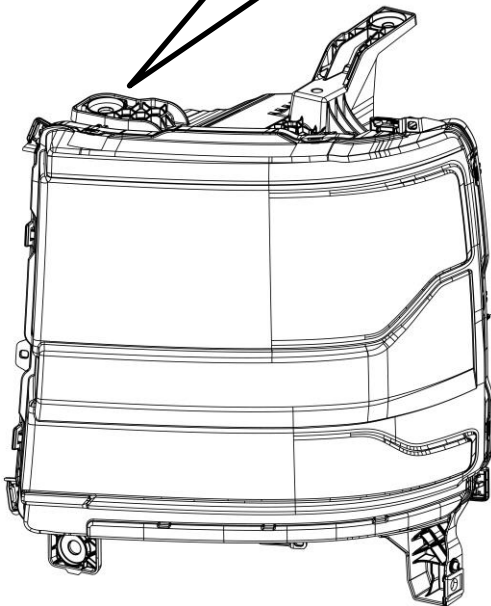
1. Using a metric scale or ruler, measure your lamp at the reference points given in the figure below.
2. If the broken mounting tab meets the Minimum Material Condition value(MIN), then your lamp can be repaired using this kit.
3. If the broken mounting tab does not meet the Minimum Material Condition value(MIN), then your lamp is not a candidate for this repair kit.
4. If your lamp's mounting tabs have been repaired previously by any method, then your lamp is not a candidate for this repair kit.
