2016-18 CHEVY SILVERADO 1500 HID LED LH UPR INBOARD HEADLIGHT TAB KIT P/N 25-10041

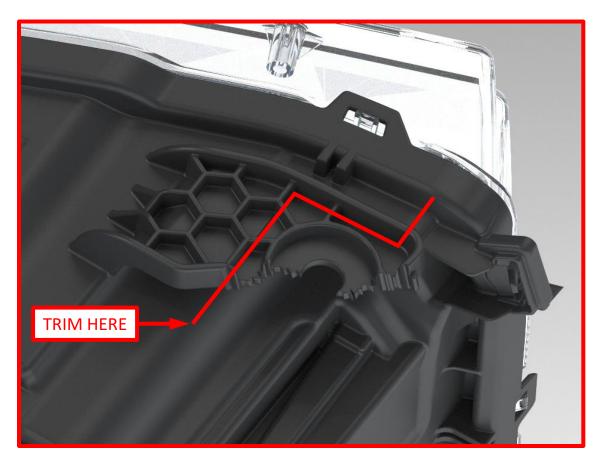
1. Trim: Using a cut-off wheel, trim the damaged tab to the MAX dimension whenever possible, Fig. 1. Make note of the trimming plane to which the MAX dimension refers, Fig. 2. The MIN indicates the least amount of material allowed for proper screw engagement. Next, Sand rough edges to remove excess material from trimming and to ensure a proper fit.
