2016-18 CHEVY SILVERADO 1500 HID LED LH UPR OUTBOARD HEADLIGHT TAB KIT P/N 25-10042

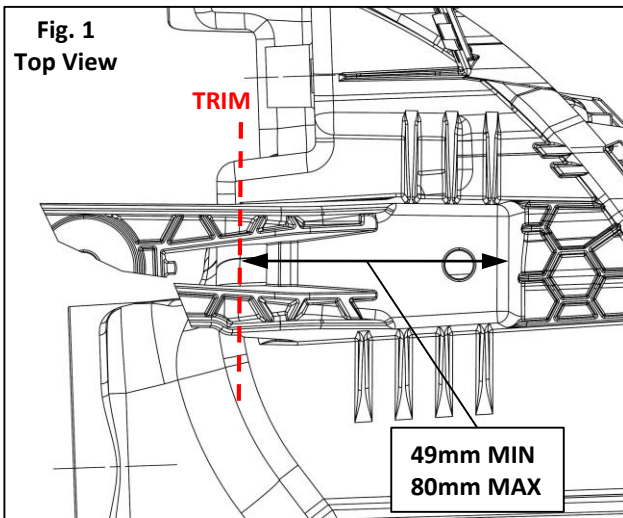
1. Trim: Using a cut-off wheel, trim the damaged tab to the **MAX** dimension whenever possible, **Fig. 1**. Make note of the trimming plane to which the **MAX** dimension refers, **Fig. 2**. The **MIN** indicates the least amount of material allowed for proper screw engagement. Next, Sand rough edges to remove excess material from trimming and to ensure a proper fit.

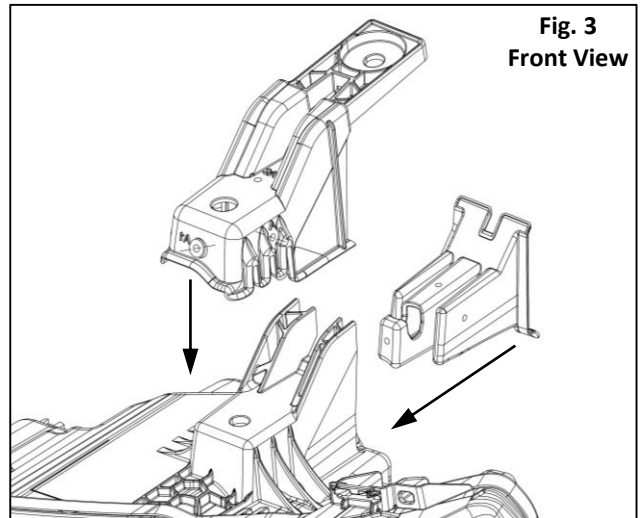
2. Dry-Fit: Dry-fit the repair tab(s) **Fig. 3**. If the tab fits without resistance and makes a flush fit to the housing, trimming is complete. If the tab resists installation re-trim the damaged tab, removing only small amounts of material. Repeat the Dry-Fit steps until the proper fit is achieved.

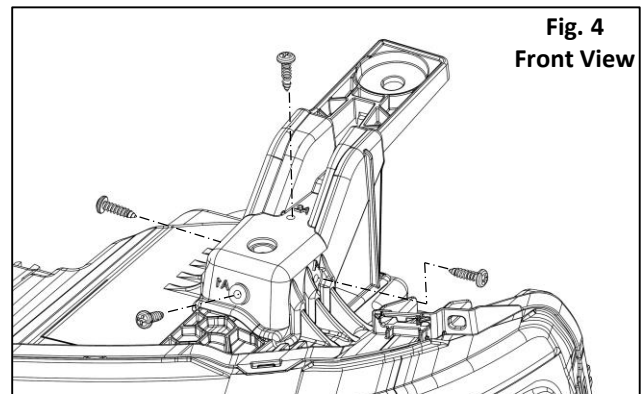
4. Install: Install the prepared tab(s) ensuring a flush fit to the housing **Fig. 4**. Drive the 5/8" screws at the locations marked (A1), followed by (A2) then location (A). Do not overtighten the screws. Allow the glue to cure for approximately 30 minutes before installing the repaired headlight on the vehicle.

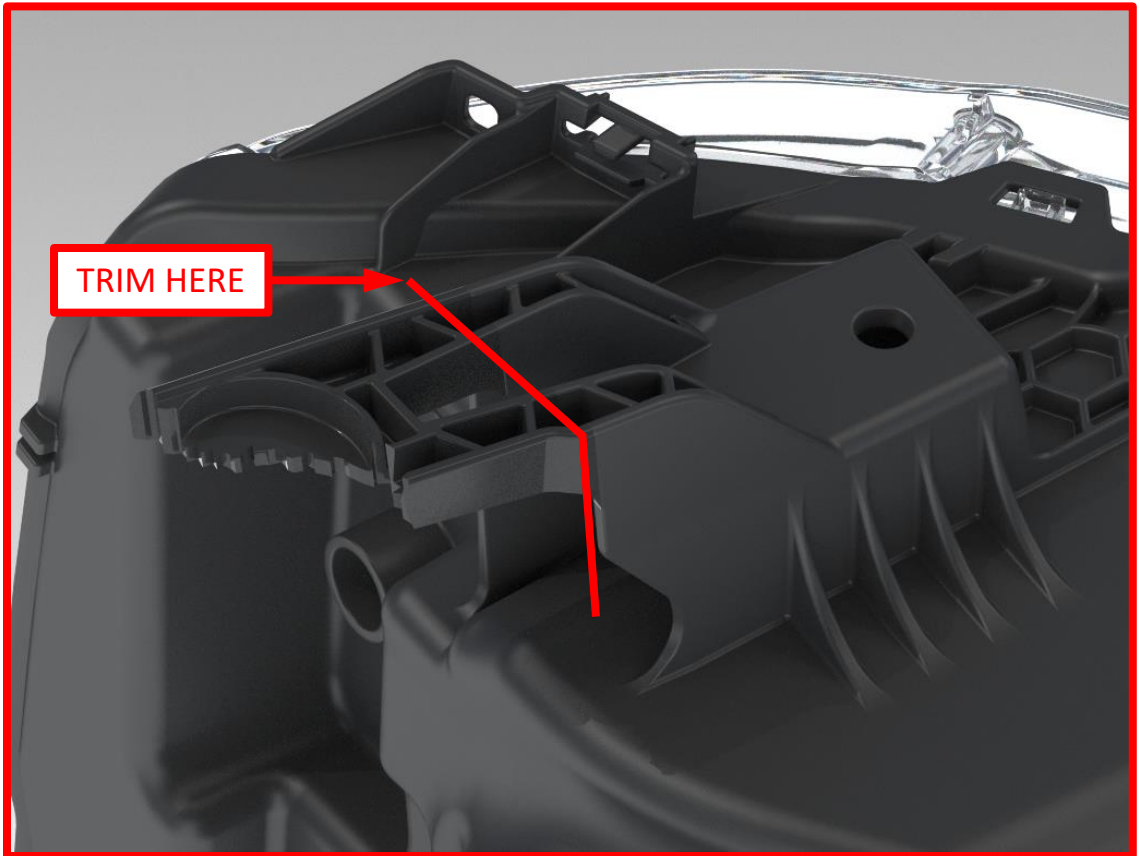
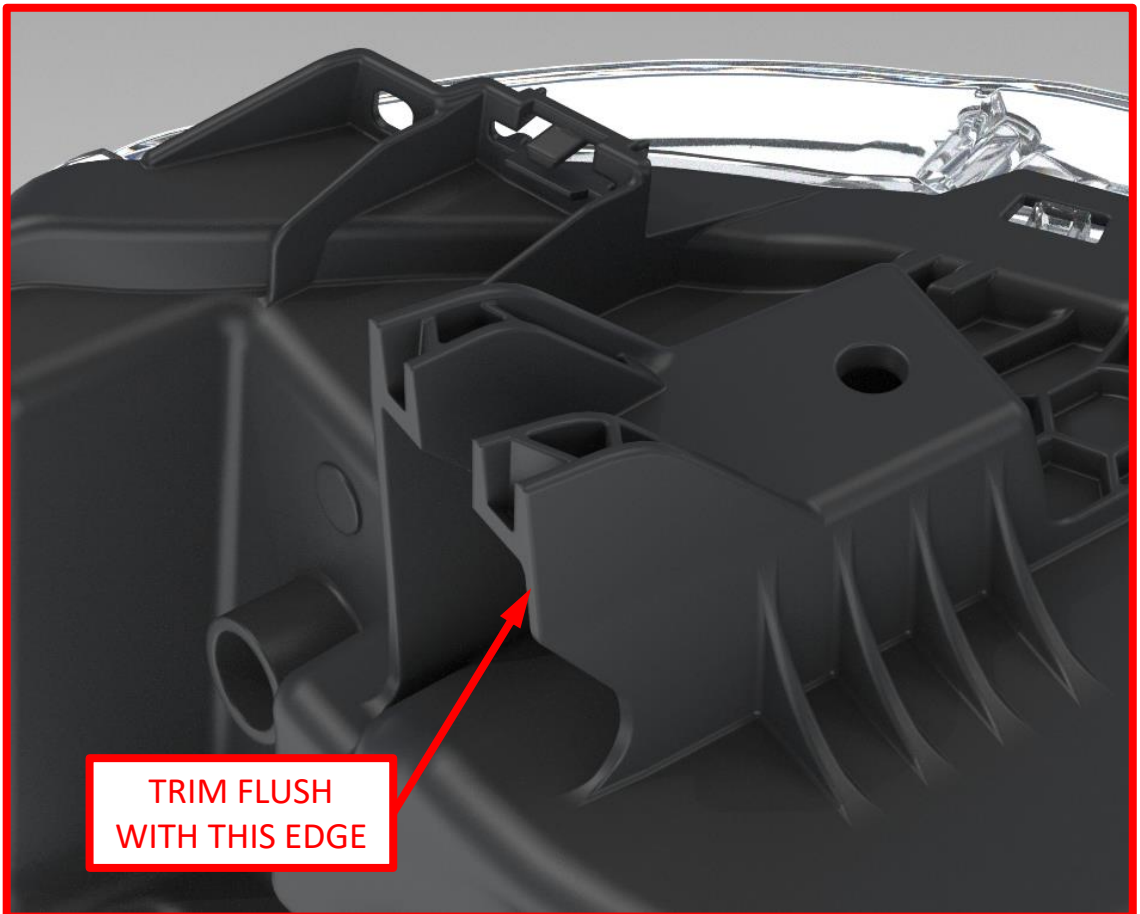
SEE REVERSE SIDE for views of properly trimmed headlamp tab.
