Minimum Material Condition (MMC) TAHOE/SUBURBAN RH UPR OUTBOARD HEADLIGHT TAB HID P/N 25-10075

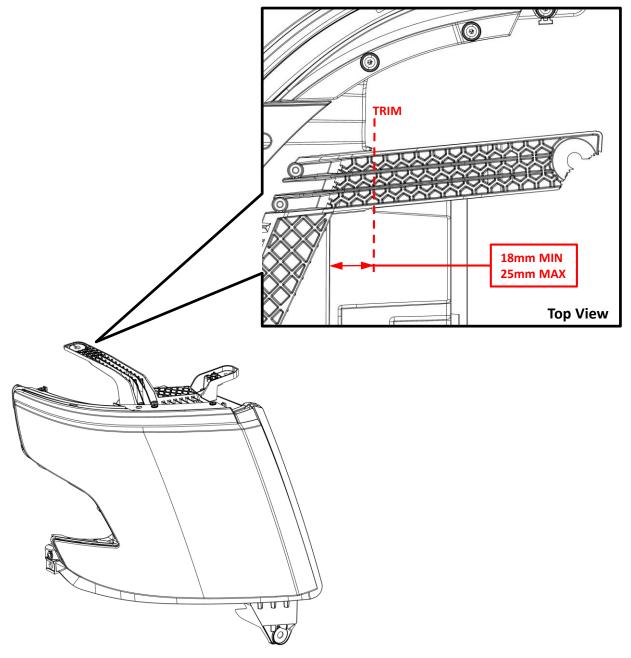
- 1. Using a metric scale or ruler, measure your lamp at the reference points given in the figure below.
- 2. If the broken mounting tab meets the Minimum Material Condition value(MIN), then your lamp can be repaired using this kit.
- 3. If the broken mounting tab does not meet the Minimum Material Condition value(MIN), then your lamp is not a candidate for this repair kit.
- 4. If your lamp's mounting tabs have been repaired previously by any method, then your lamp is not a candidate for this repair kit.
