**Minimum Material Condition (MMC)**  
**EQUINOX LH LWR INBOARD HEADLIGHT TAB HAL**  
**P/N 25-10073**

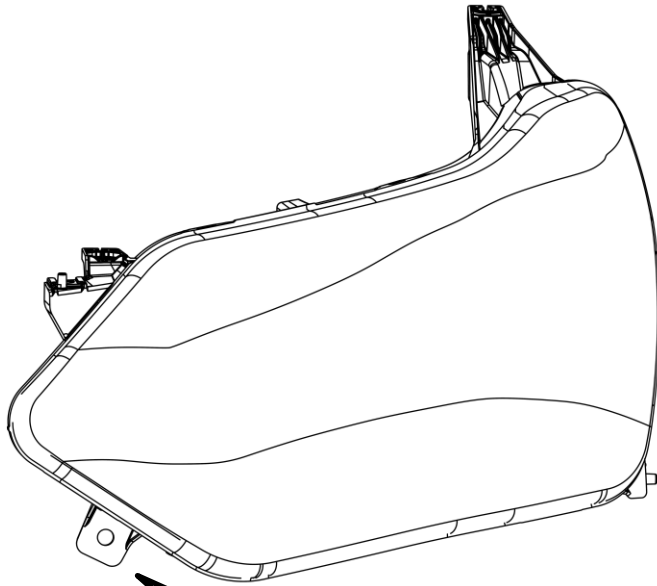
1. Using a metric scale or ruler, measure your lamp at the reference points given in the figure below.
2. If the broken mounting tab meets the Minimum Material Condition value(MIN), then your lamp can be repaired using this kit.
3. If the broken mounting tab does not meet the Minimum Material Condition value(MIN), then your lamp is not a candidate for this repair kit.
4. If your lamp's mounting tabs have been repaired previously by any method, then your lamp is not a candidate for this repair kit.
