Minimum Material Condition (MMC)
EQUINOX LH UPR INBOARD HEADLIGHT TAB HAL
P/N 25-10072

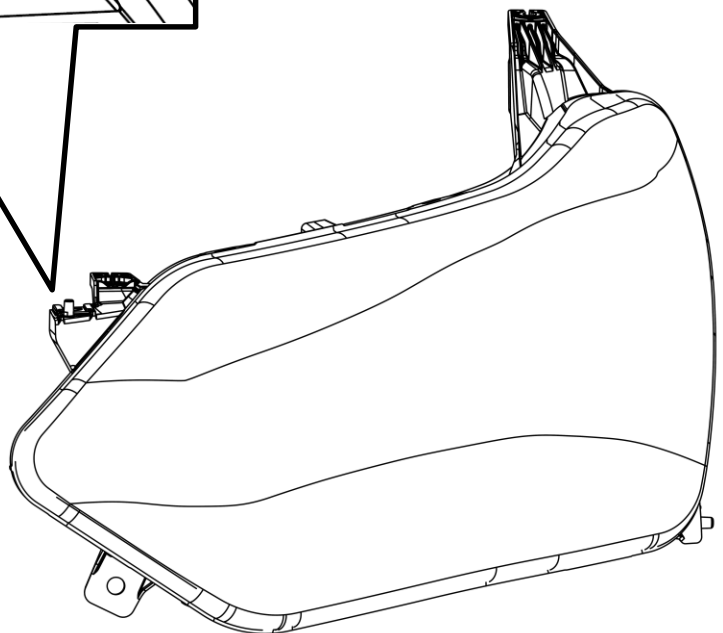
1. Using a metric scale or ruler, measure your lamp at the reference points given in the figure below.
2. If the broken mounting tab meets the Minimum Material Condition value(MIN), then your lamp can be repaired using this kit.
3. If the broken mounting tab does not meet the Minimum Material Condition value(MIN), then your lamp is not a candidate for this repair kit.
4. If your lamp's mounting tabs have been repaired previously by any method, then your lamp is not a candidate for this repair kit.
