Minimum Material Condition (MMC)
EQUINOX LH UPR INBOARD HEADLIGHT TAB HID
P/N 25-10052

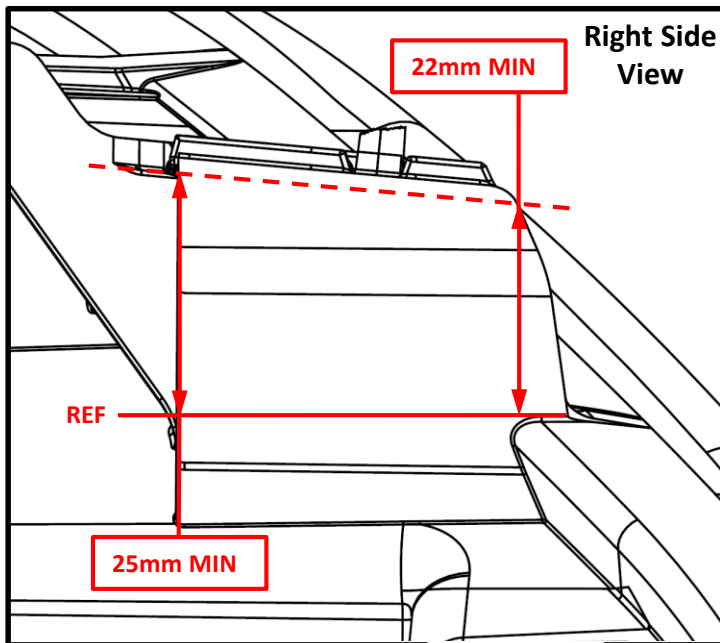
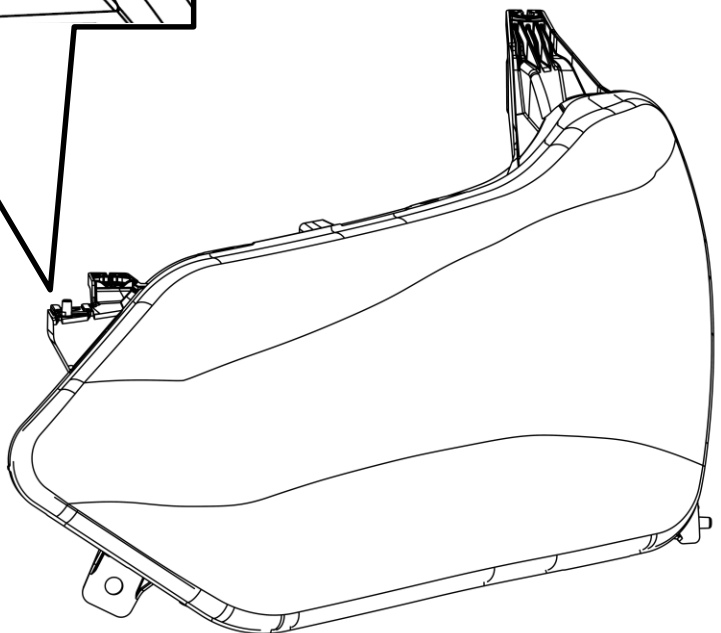
1. Using a metric scale or ruler, measure your lamp at the reference points given in the figure below.
2. If the broken mounting tab meets the Minimum Material Condition value(MIN), then your lamp can be repaired using this kit.
3. If the broken mounting tab does not meet the Minimum Material Condition value(MIN), then your lamp is not a candidate for this repair kit.
4. If your lamp's mounting tabs have been repaired previously by any method, then your lamp is not a candidate for this repair kit.
