Minimum Material Condition (MMC)
EQUINOX LH UPR OUTBOARD HEADLIGHT TAB HAL
P/N 25-10070

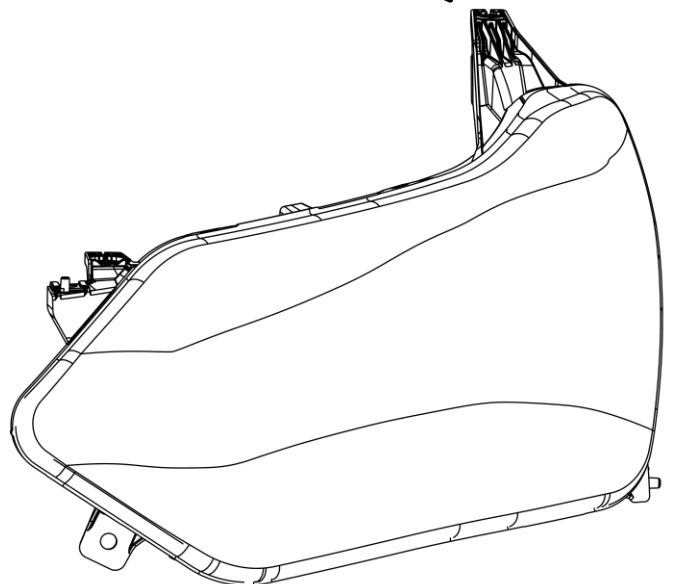
1. Using a metric scale or ruler, measure your lamp at the reference points given in the figure below.
2. If the broken mounting tab meets the Minimum Material Condition value(MIN), then your lamp can be repaired using this kit.
3. If the broken mounting tab does not meet the Minimum Material Condition value(MIN), then your lamp is not a candidate for this repair kit.
4. If your lamp's mounting tabs have been repaired previously by any method, then your lamp is not a candidate for this repair kit.
