Minimum Material Condition (MMC)
EQUINOX LH UPR OUTBOARD HEADLIGHT TAB HID
P/N 25-10050

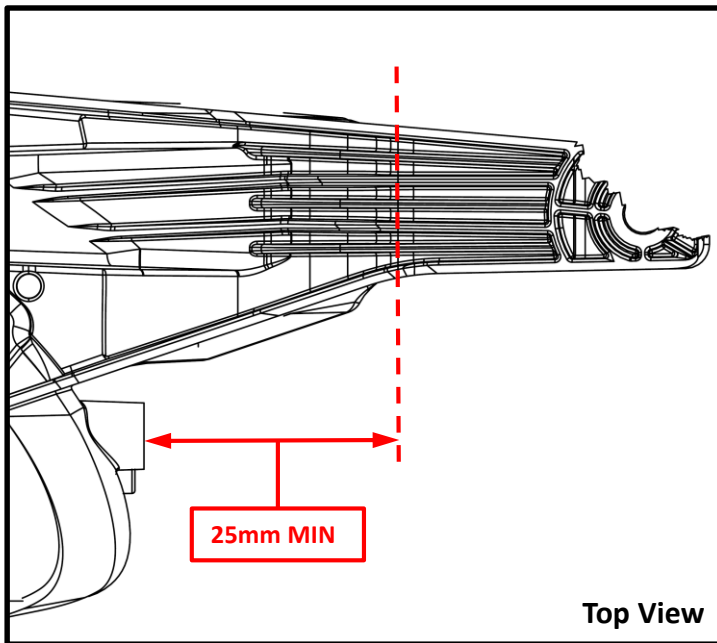
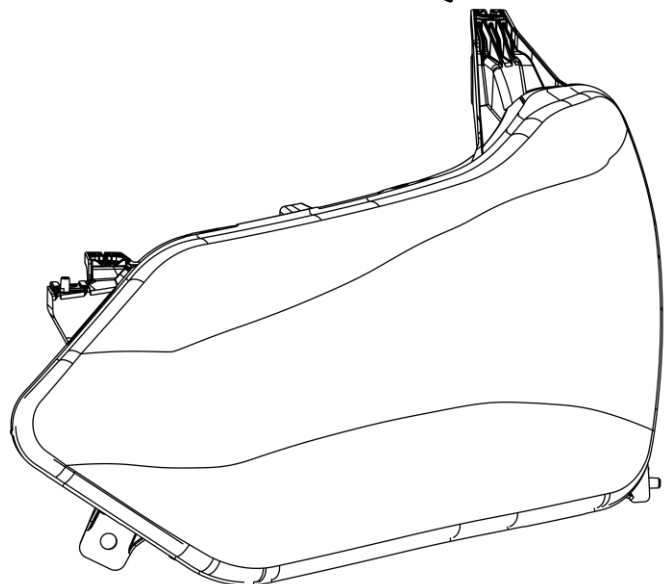
1. Using a metric scale or ruler, measure your lamp at the reference points given in the figure below.
2. If the broken mounting tab meets the Minimum Material Condition value(MIN), then your lamp can be repaired using this kit.
3. If the broken mounting tab does not meet the Minimum Material Condition value(MIN), then your lamp is not a candidate for this repair kit.
4. If your lamp's mounting tabs have been repaired previously by any method, then your lamp is not a candidate for this repair kit.
