**Minimum Material Condition (MMC)**  
**EQUINOX RH LWR OUTBOARD HEADLIGHT TAB HID**  
**P/N 25-10049**

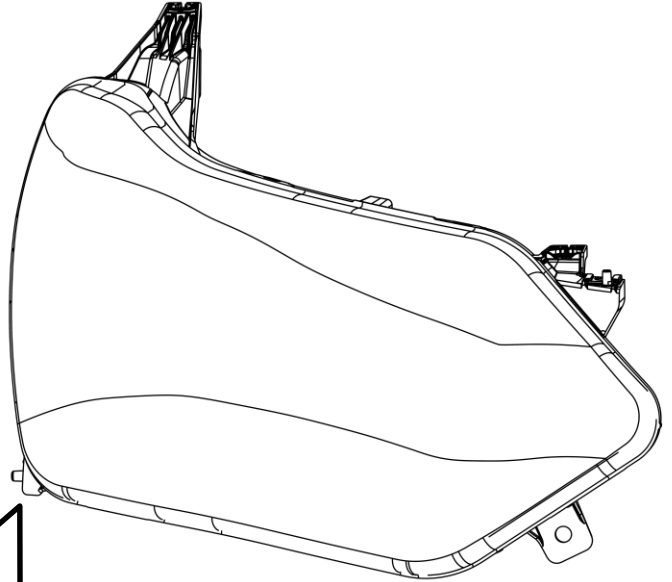
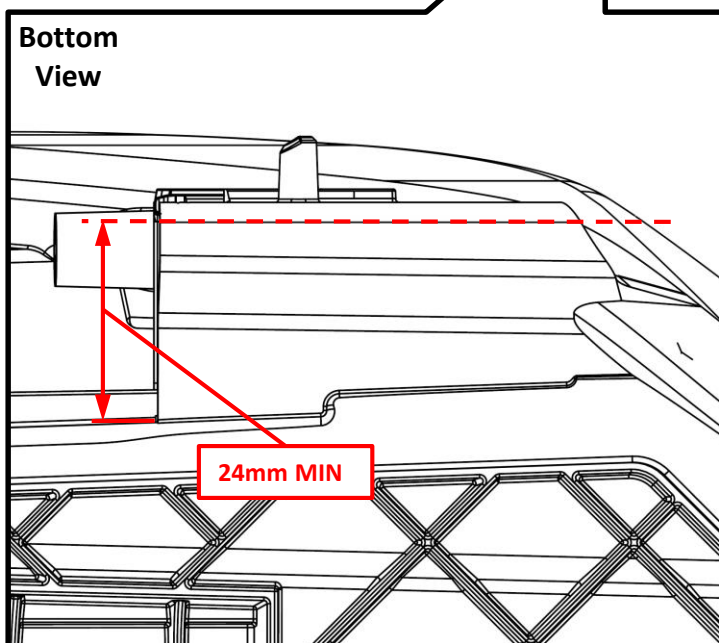
1. Using a metric scale or ruler, measure your lamp at the reference points given in the figure below.
2. If the broken mounting tab meets the Minimum Material Condition value(MIN), then your lamp can be repaired using this kit.
3. If the broken mounting tab does not meet the Minimum Material Condition value(MIN), then your lamp is not a candidate for this repair kit.
4. If your lamp's mounting tabs have been repaired previously by any method, then your lamp is not a candidate for this repair kit.
