Minimum Material Condition (MMC)
TAHOE/SUBURBAN LH LWR INBOARD HEADLIGHT TAB HAL
P/N 25-10102

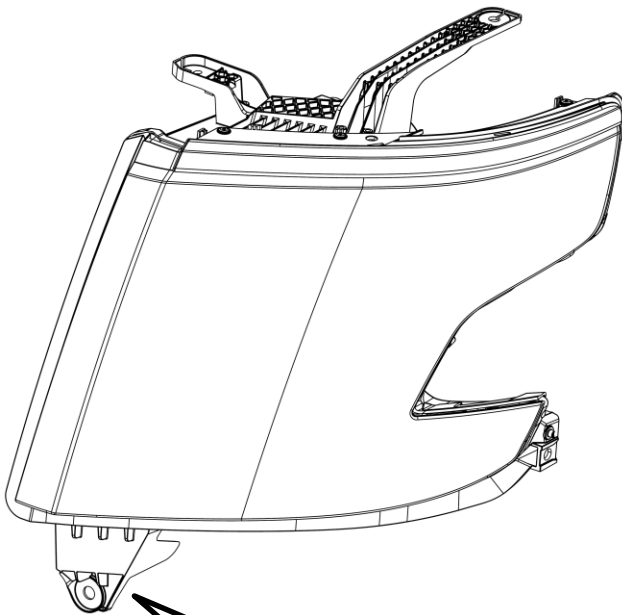
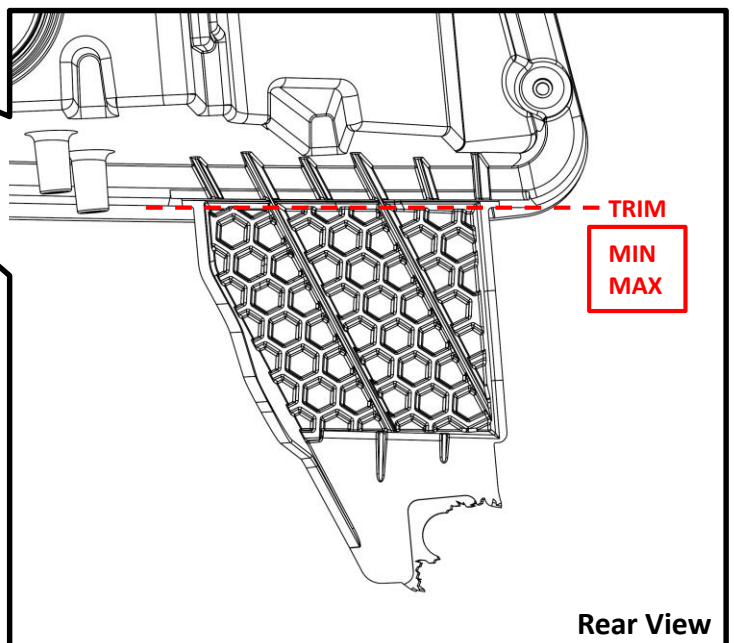
1. Using a metric scale or ruler, measure your lamp at the reference points given in the figure below.
2. If the broken mounting tab meets the Minimum Material Condition value(MIN), then your lamp can be repaired using this kit.
3. If the broken mounting tab does not meet the Minimum Material Condition value(MIN), then your lamp is not a candidate for this repair kit.
4. If your lamp's mounting tabs have been repaired previously by any method, then your lamp is not a candidate for this repair kit.
