Minimum Material Condition (MMC)
TAHOE/SUBURBAN LH UPR INBOARD HEADLIGHT TAB HID
P/N 25-10081

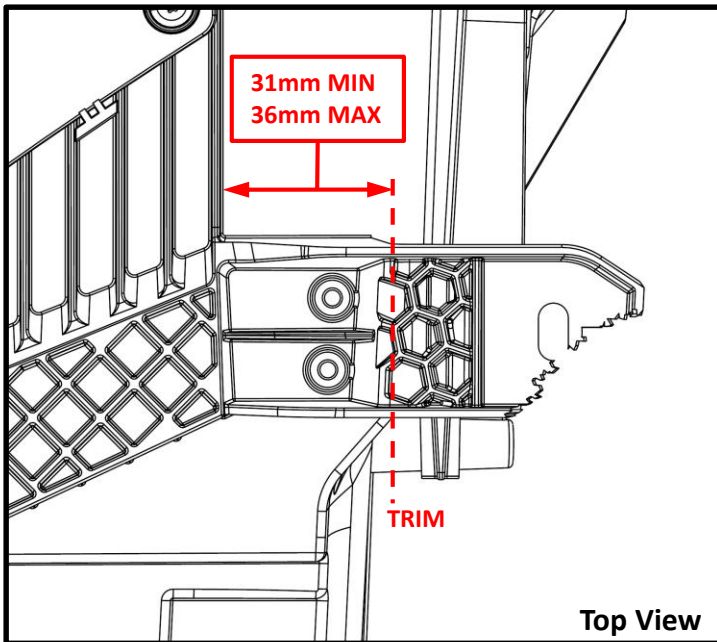
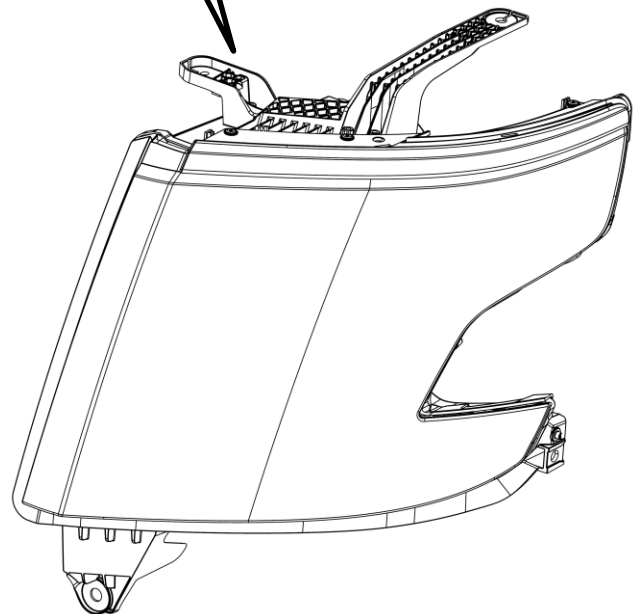
1. Using a metric scale or ruler, measure your lamp at the reference points given in the figure below.
2. If the broken mounting tab meets the Minimum Material Condition value(MIN), then your lamp can be repaired using this kit.
3. If the broken mounting tab does not meet the Minimum Material Condition value(MIN), then your lamp is not a candidate for this repair kit.
4. If your lamp's mounting tabs have been repaired previously by any method, then your lamp is not a candidate for this repair kit.
